# FLOOD PLAIN INFORMATION

*DORCHESTER, WHITMAN, QUESET,  
BLACK, BEAVER, POQUANTICUT,  
MULBERRY and GOWARDS BROOKS  
EASTON, MASSACHUSETTS*

PREPARED BY THE DEPARTMENT OF THE ARMY, NEW ENGLAND DIVISION,  
CORPS OF ENGINEERS, WALTHAM, MASSACHUSETTS

APRIL 1977

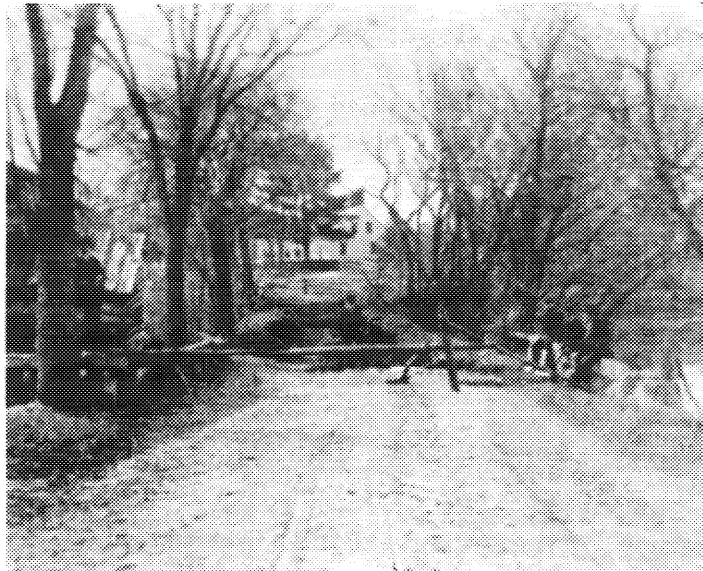
Figure 1 - Poquanticut Brook Station 25+00. Photograph of damage to Foundry Street at New Pond. (Courtesy of Mr. Clifford Grant)

The dam at what is now called New Pond was overtopped and only preventative measures by the local town folk kept it from being washed out. As shown in Figure 1, Foundry Street, just below the dam, was washed out due to the overtopping of the dam and the extreme erosive action of the water.

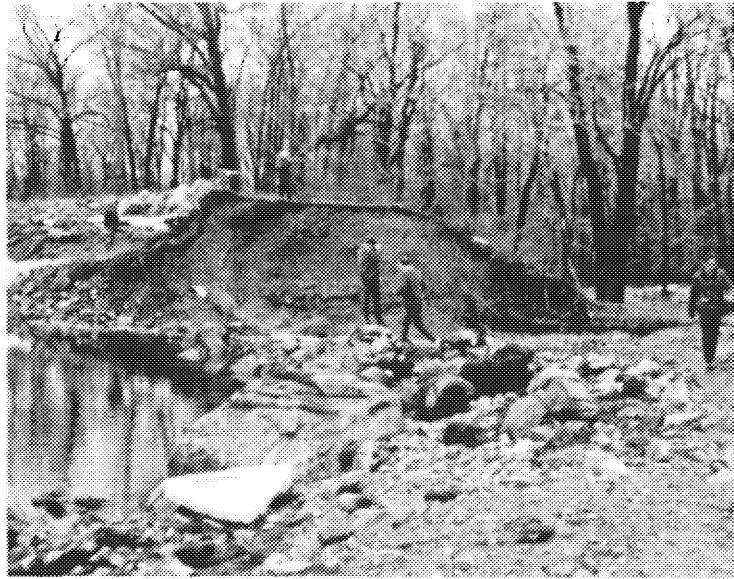
Figure 2 - Tributary to Queset Brook. Results of breaching of Flyaway Pond. (1968 Photo by Mr. Allan Watts)

The 55-acre Flyaway Pond is located west of Canton Street. The dam here was breached during the flood of 1968 causing a large amount of property damage downstream.

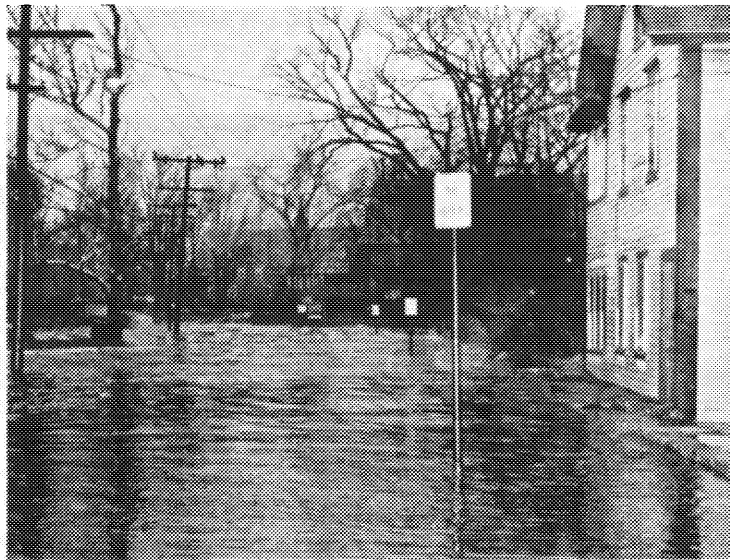
Figure 3 - Queset Brook Station 192+00. Photograph of floodwaters at Main Street in North Easton. Note water coming over wall. (Photo by Mr. Stanley Bauman)

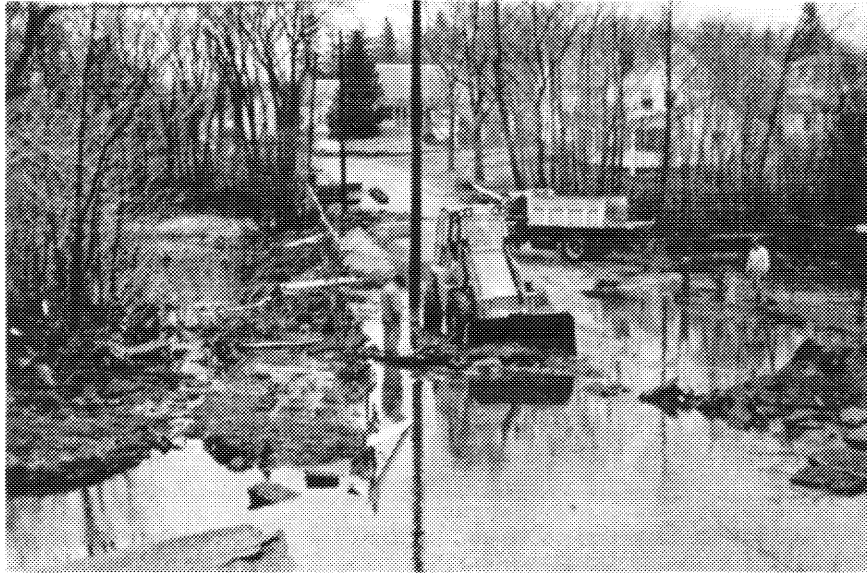
Figure 4 - Queset Brook Station 183+00. Photograph of flooding and damage at Pond Street. (Courtesy of Mr. Allan Watts)

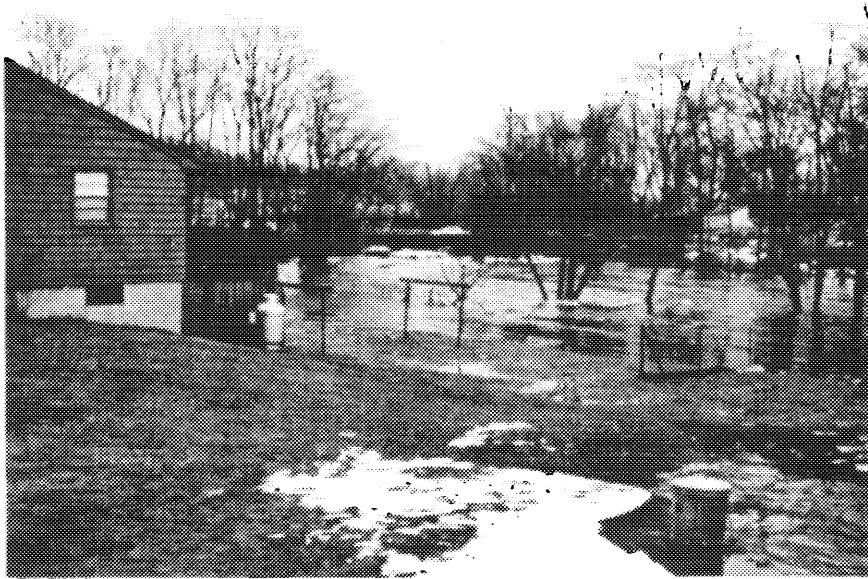
Figure 6 - Queset Brook vicinity of Station 85+00. Photograph of floodwaters and melting snow cover behind Short Street. (Courtesy of Mr. Allan Watts)

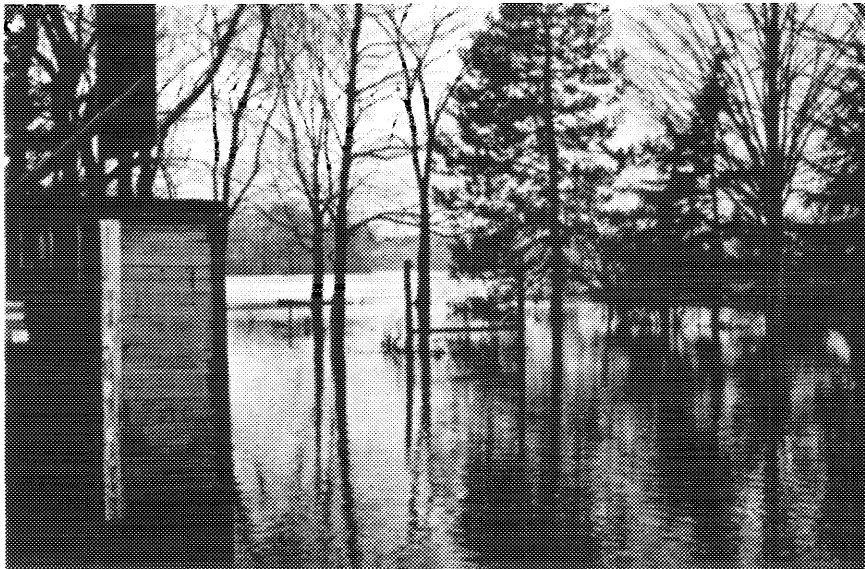
Figure 7 - Queset Brook vicinity of Station 85+00. Photograph of Morse Pond overtopping into the surrounding low areas.

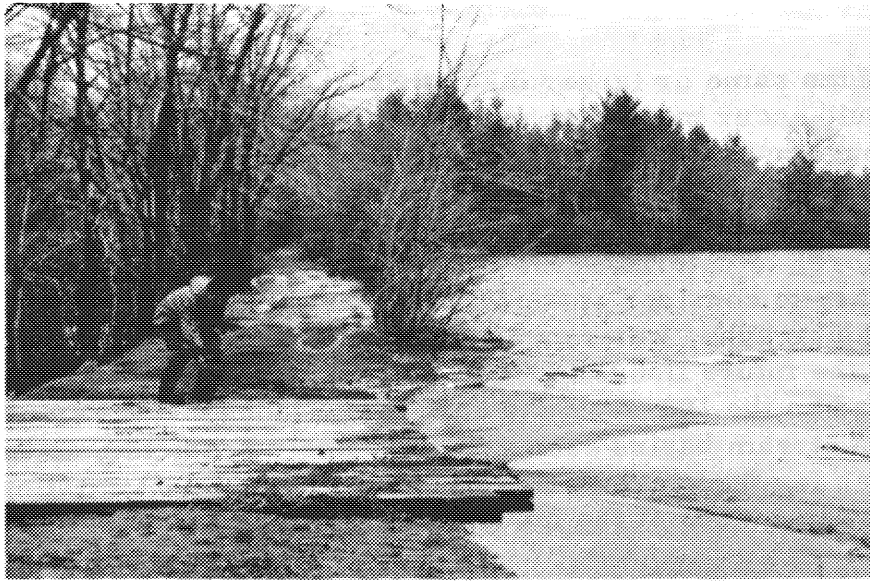
**Figure 8 - Mulberry Brook Station 33+00. Photograph of floodwaters at Ward Pond in Wheaton Farm. Note ice sheets. (Courtesy of Mr. Allan Watts)**

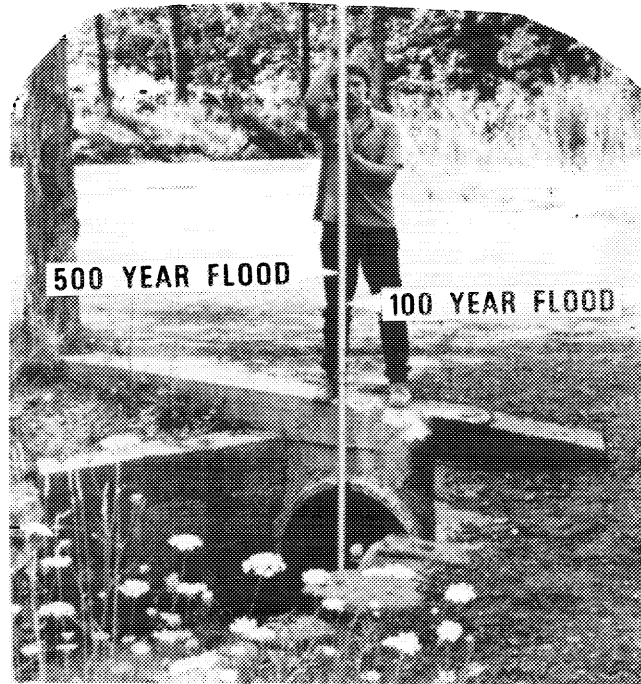
FIGURE 10 - Dorchester Brook, Station 78+00. Future flood heights at culvert on west side of French Pond.

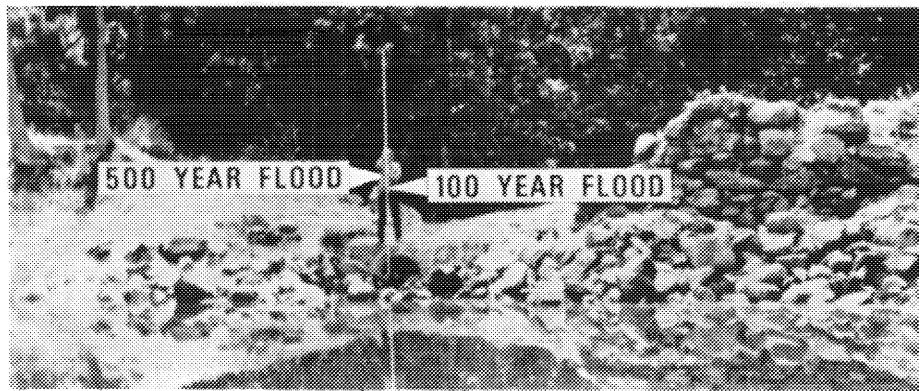
FIGURE 11 - Dorchester Brook, Station 31+00. Future flood heights at breached dam of Monte Pond.

The dam at Monte Pond, just north of Elm Street, was purposely breached in June of 1974. This decision was made because of the questionable structural integrity of the old dam and thus by breaching the dam, possible serious future flood damage due to failure of the dam would be averted.

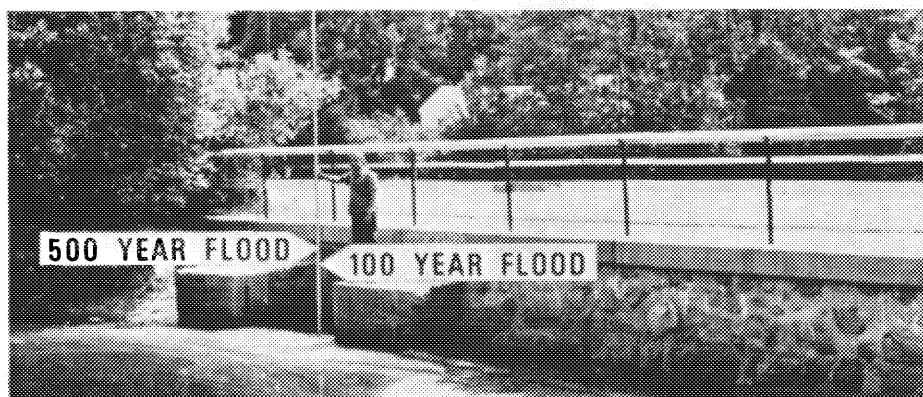
**FIGURE 12 - Dorchester Brook, Station 0+00. Future flood heights at Bigney Pond just north of Torrey Street in Brockton.**

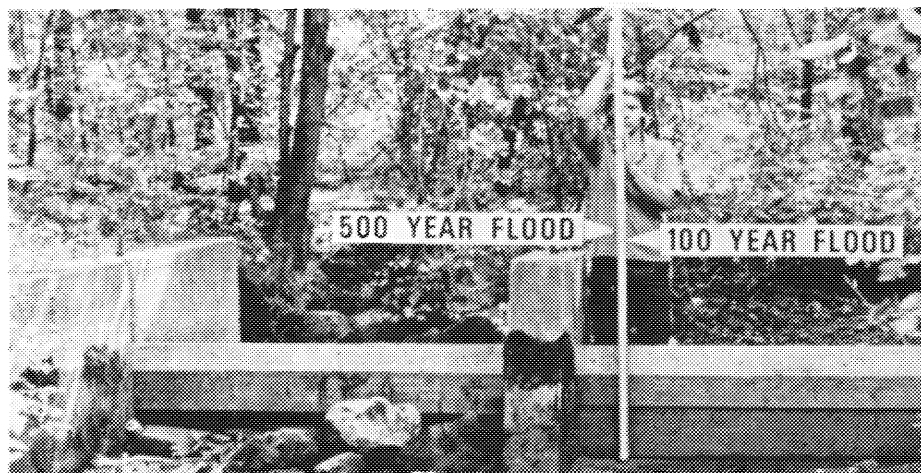
**FIGURE 13 - Queset Brook, Station 251+50. Future flood heights at spillway of Ames Long Pond.**

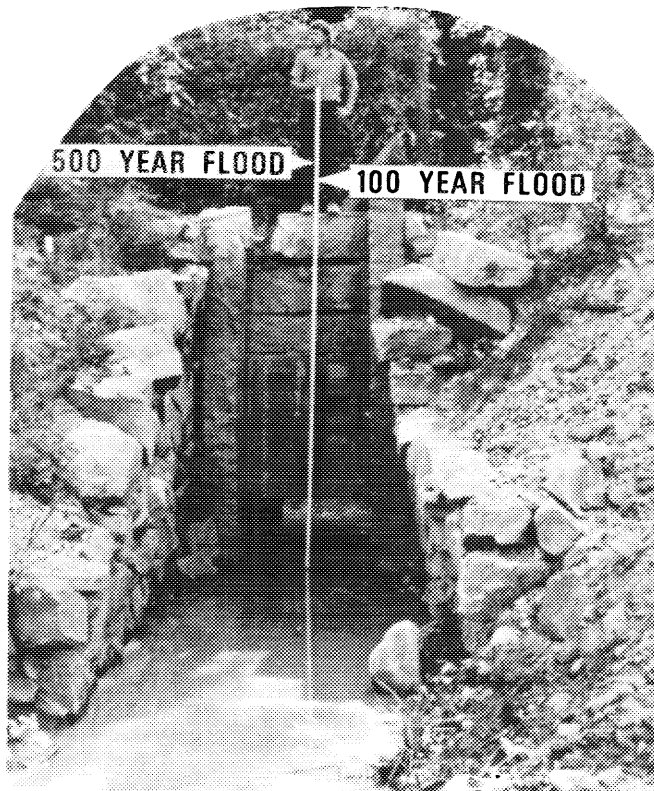
FIGURE 17 - Queset Brook, Station 174+00. Future flood heights at breached dam at Shovelshop Pond.

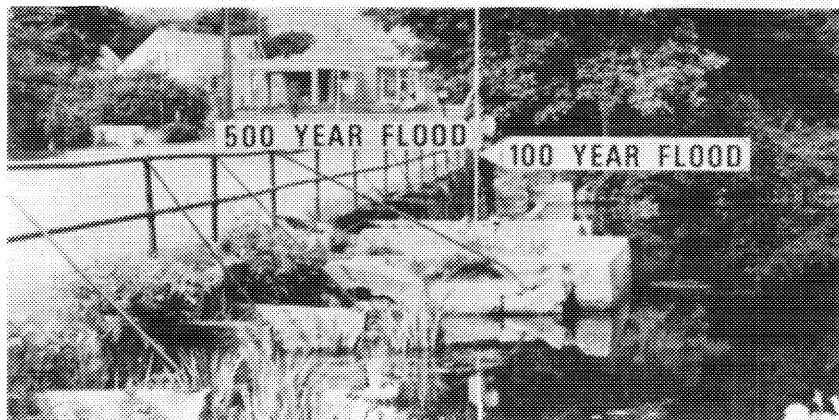
FIGURE 18 - Queset Brook, Station 156+00. Future flood heights at Langwater Pond and Main Street.

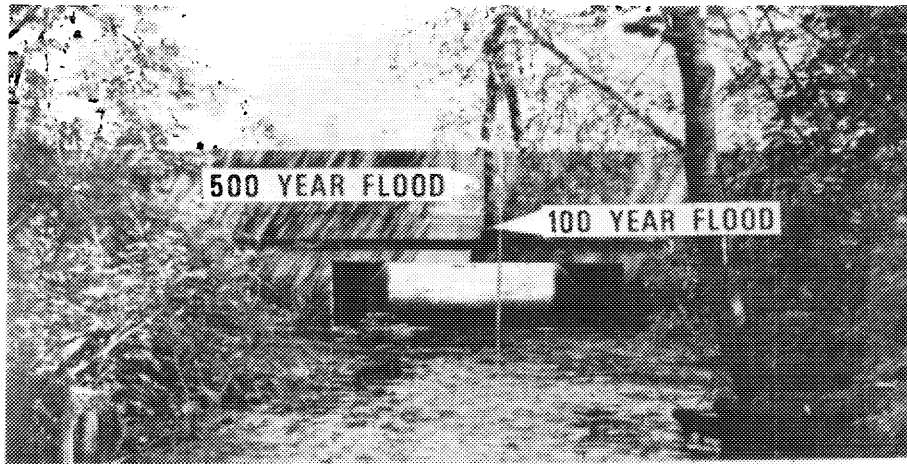
FIGURE 25 - Black Brook, Station 45+00. Future flood heights at Turnpike Street (Rte. 138).
